RE: Closure of the Small Fry Mine M/037/022, San Juan County, Utah.

RE: Reclamation Closure Report for the Small Fry Mine, San Juan County, Utah

ATTACHMENT A – PHOTOGRAPHS

**Small Fry Mine Site
San Juan County, Utah**

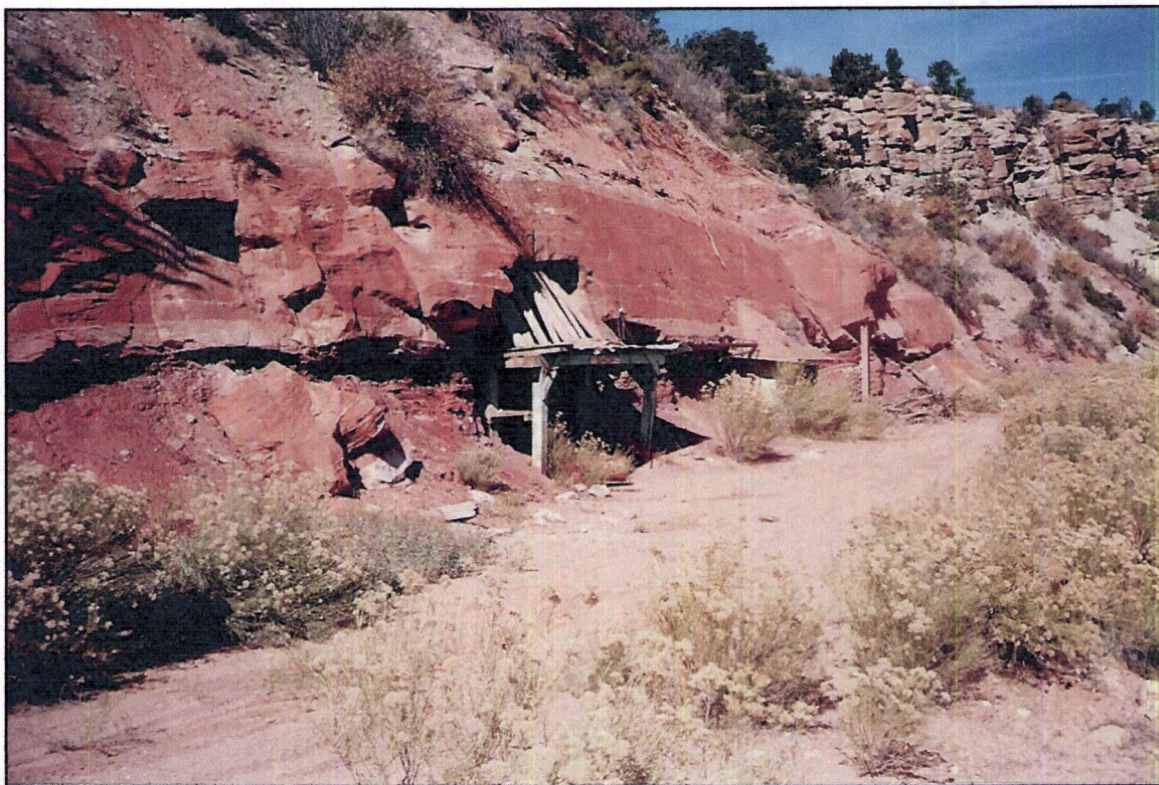
The mine bench was constructed on the east-facing escarpment, which is bounded above by a natural terrace that overlies the mine workings. In addition to the mine portal, five other excavations were constructed into the rock wall on the mine bench (Attachment A – Photographs 1 through 4). The excavations were apparently used for an office, a shop, two magazines, and a compressor shack. Timbers were used to secure and enclose each excavation. A large level area on the natural terrace below the mine bench was apparently used for parking and equipment/material storage. A number of prospects/adits were excavated into the escarpment above the mine bench and south of the primary mine portal (Attachment A – Photograph 5). The mine access road extends approximately ¼ mile from the portal area to an unpaved county road which joins the Big Indian Valley County Road within about ½ mile of the Site.

Photo 1: Small Fry Mine - Portal bench area and former mine shop

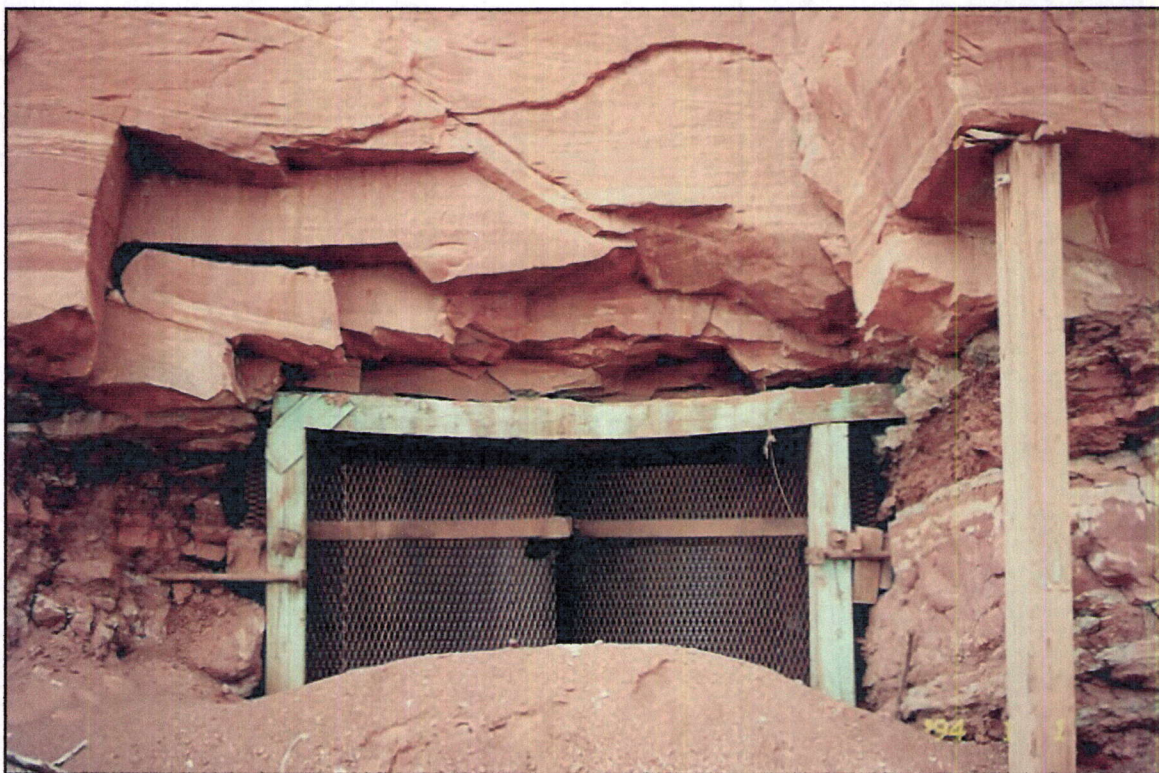
Photo 2: Small Fry Mine – Main portal

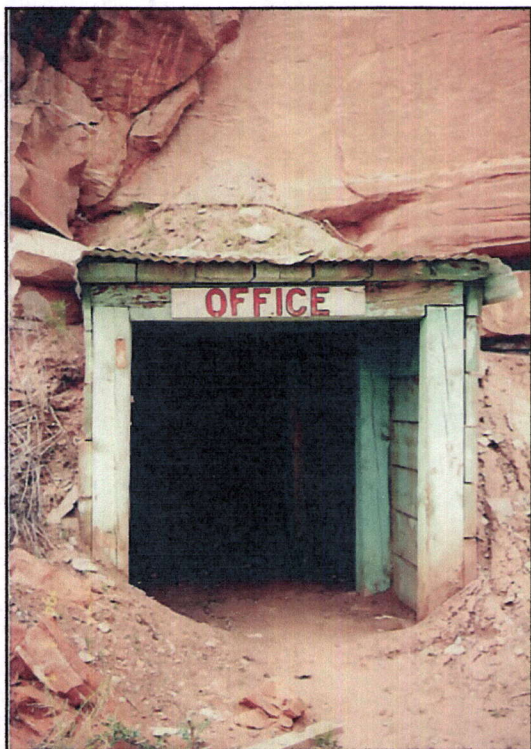
Photo 3: Small Fry Mine - Office

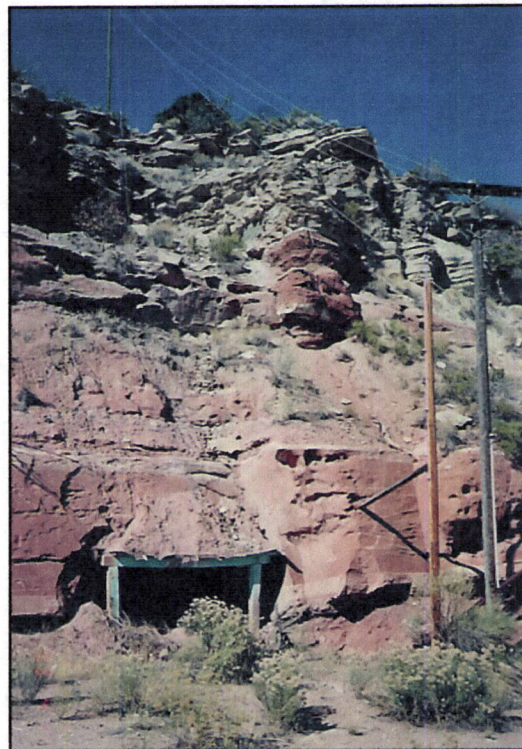
Photo 4: Small Fry Mine - Power line

A power line extended from the portal bench to the escape/ventilation shaft. The line and associated poles were removed by Utah Power.

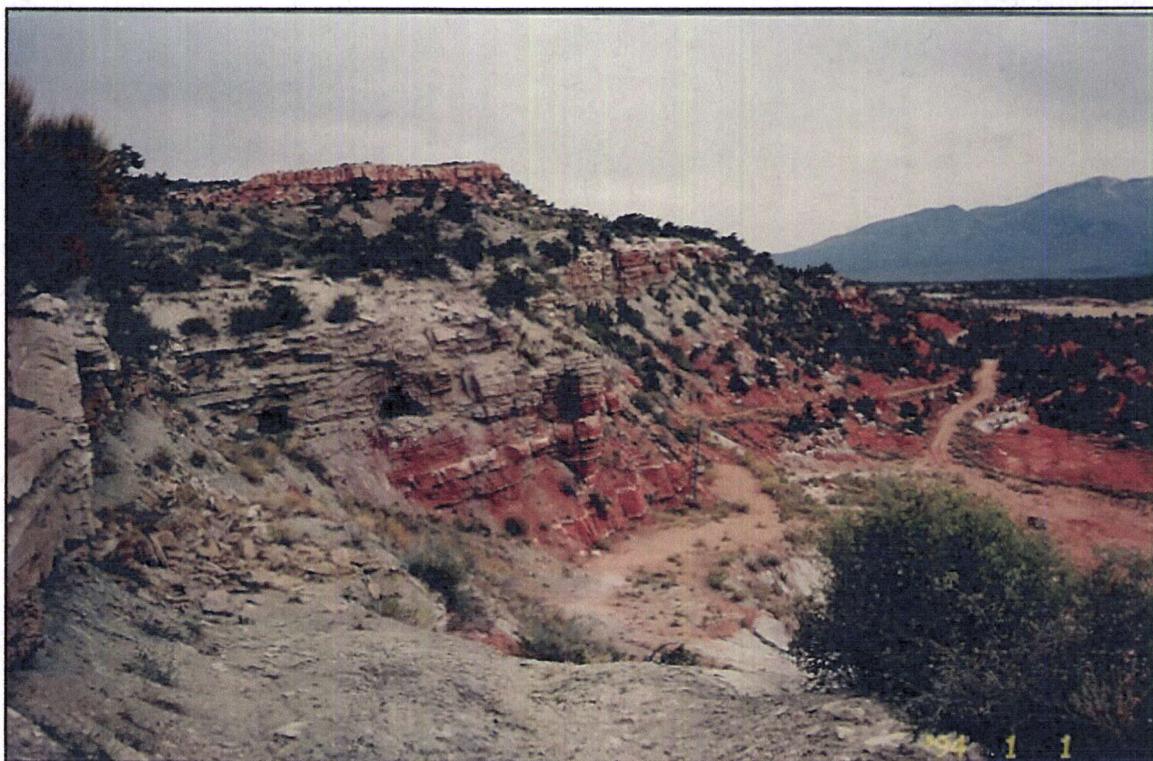
Photo 5: Small Fry Mine – Prospects/adits above the mine bench and south of the mine portal (excavations shown in left-central portion of photograph).

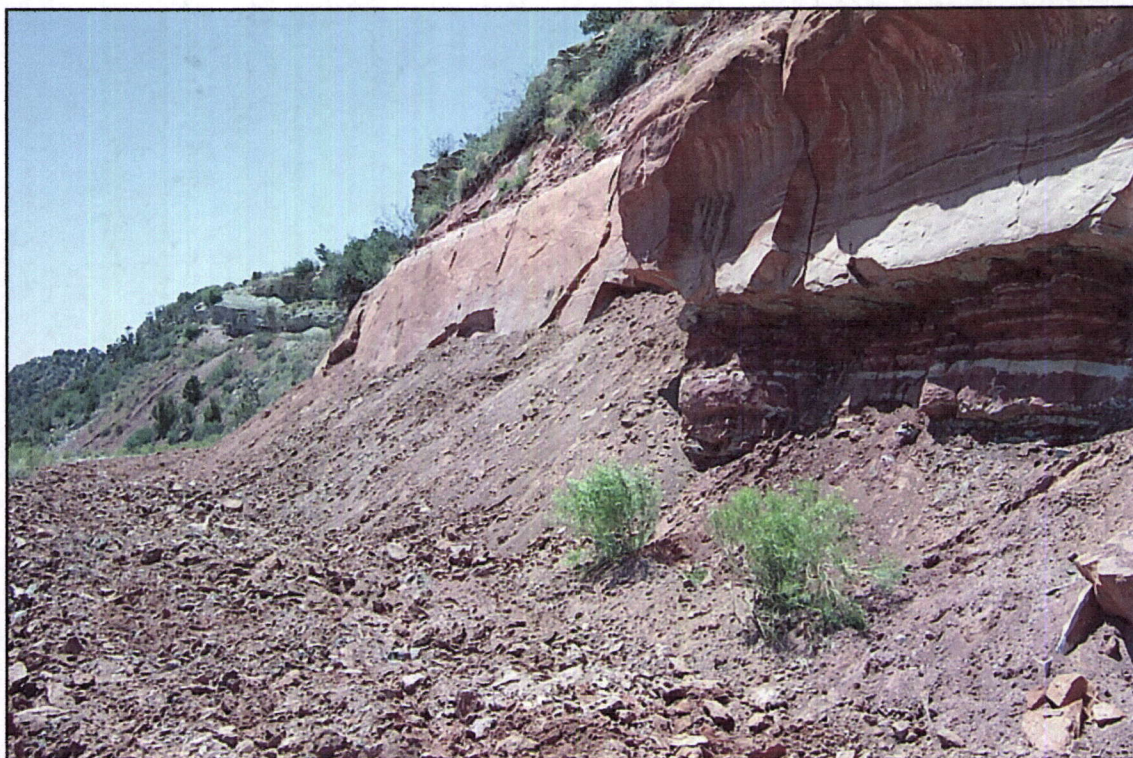
Photo 6: Small Fry Mine – Portal bench area following reclamation.

The mine portal and other excavations constructed on the mine bench were permanently sealed by removing timbers and wooden siding extending beyond the portal/excavation openings and backfilling the openings with unconsolidated sediment (Attachment A – Photograph 6). The backfill material was obtained from the side slope of the mine bench. To promote revegetation of backfilled areas, the upper 1 foot of backfilled material was composed predominantly of red (oxidized) sandy silt which is more conducive to re-establishment of natural vegetation than the underlying backfill material composed of primarily of gray (reduced) silty clay. The resulting slope formed along the portal area was contoured to match the slope above the bedrock outcrop. The surface of the mine bench was ripped in preparation for subsequent seeding. To avoid unnecessary disturbance of established vegetation on the mine bench side slope, the decision was made in consultation with DOGM personnel to rip the bench in place rather than to regrade the bench to match the pre-mine topography.

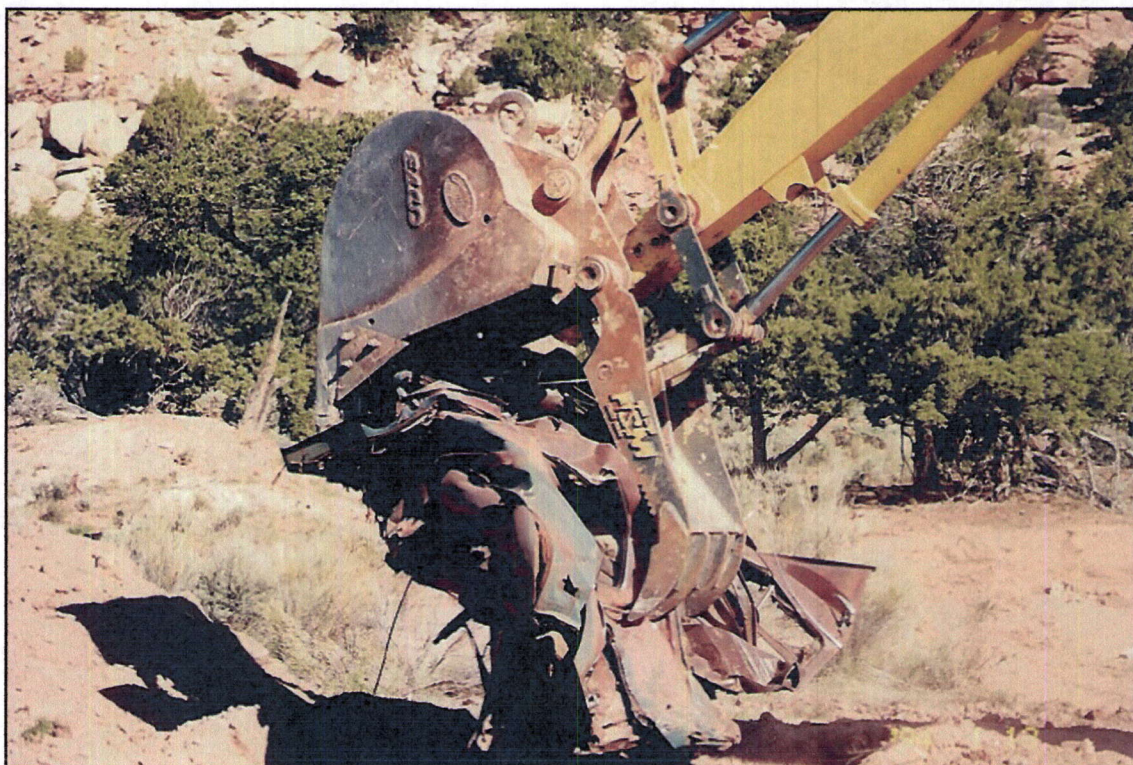
Photo 7: Small Fry Mine – Crushed car body deposited in shaft.

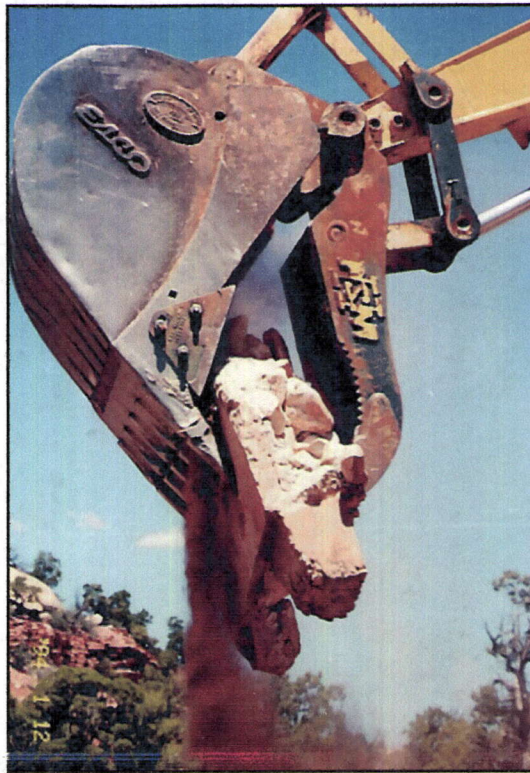
Photo 8: Small Fry Mine – Concrete rubble deposited in the shaft.

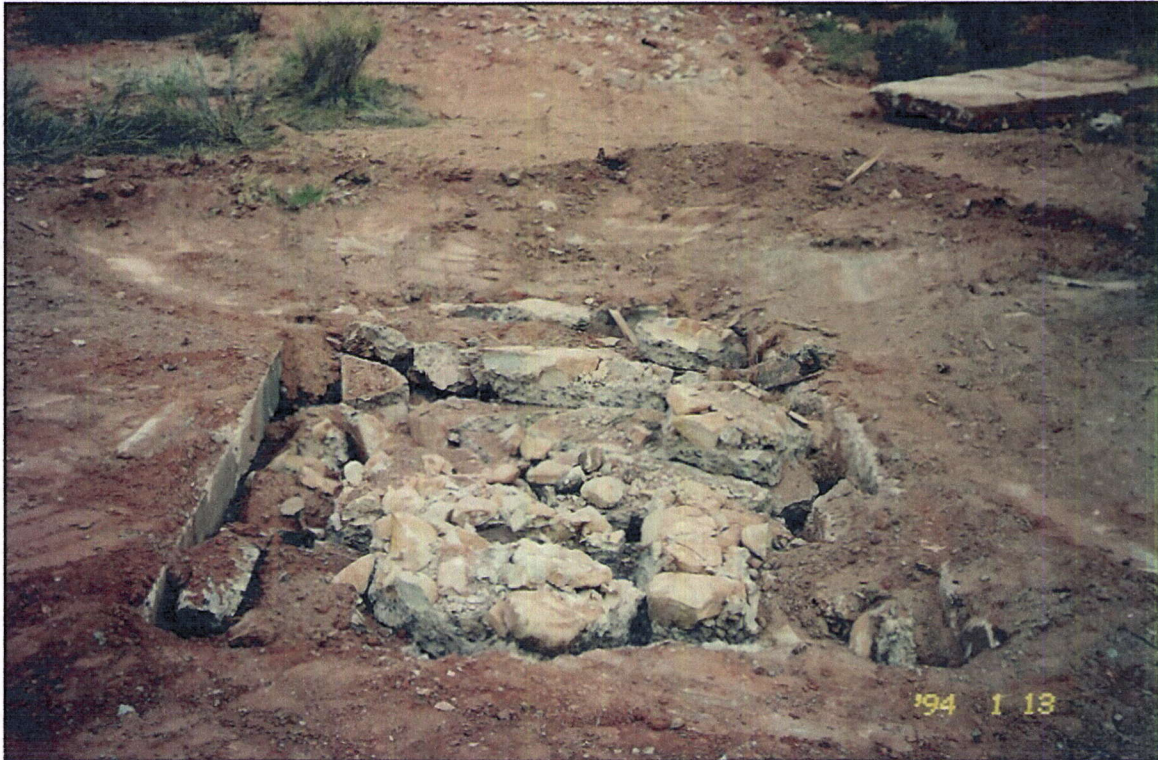
Photo 9: Sealed shaft opening prior to placement of concrete cap.

The escape/ventilation shaft was located on the natural bench overlying the mine workings, approximately 1,000 feet west of the rim above the mine portal area. The metal cap covering the shaft was removed, crushed, and disposed of in the shaft. In addition, the timbers and wooden structures used to crib the upper portion of the shaft were removed and the material disposed of in the shaft. The concrete collar surrounding the shaft was left in place. The shaft was filled by depositing concrete rubble, crushed car bodies, wooden structure debris, and general rubbish scattered across the natural terrace in the shaft. The car bodies were crushed prior to being deposited in the shaft (Attachment A – Photograph 7). Large blocks of concrete rubble were used to dislodge any bridges that formed in the shaft during closure operations (Attachment A – Photograph 8). A solid bridge formed at a depth of 41 feet below the ground surface. Repeated attempts were made to dislodge the bridge which could not be broken, and therefore, the bridge was used as the base of shaft plug. The remaining portion of the shaft was filled, as described above, to the ground surface (Attachment A – Photograph 9).

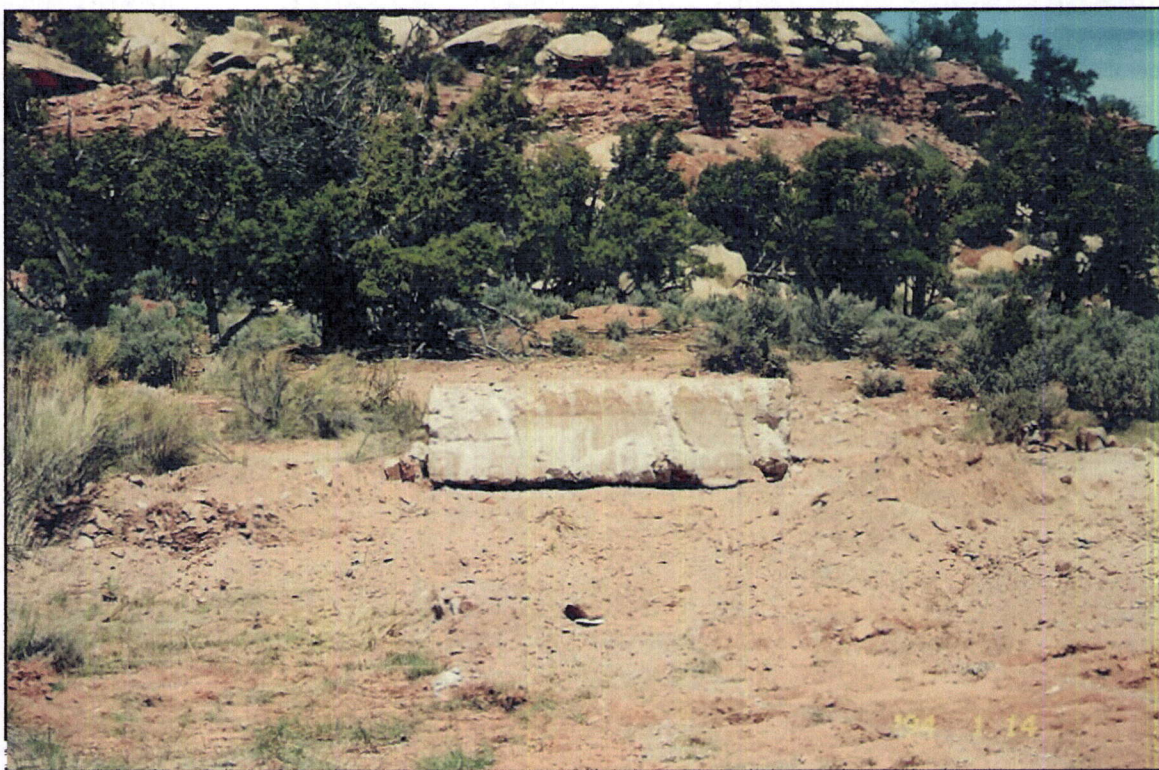
Photo 10: Concrete cap over former shaft opening.

A large block of concrete measuring approximately 10 feet by 10 feet by 2.5 feet thick was placed over the top of the shaft as a cap (Attachment A – Photograph 10). The cap was placed on the concrete collar of the shaft such that three sides of the cap

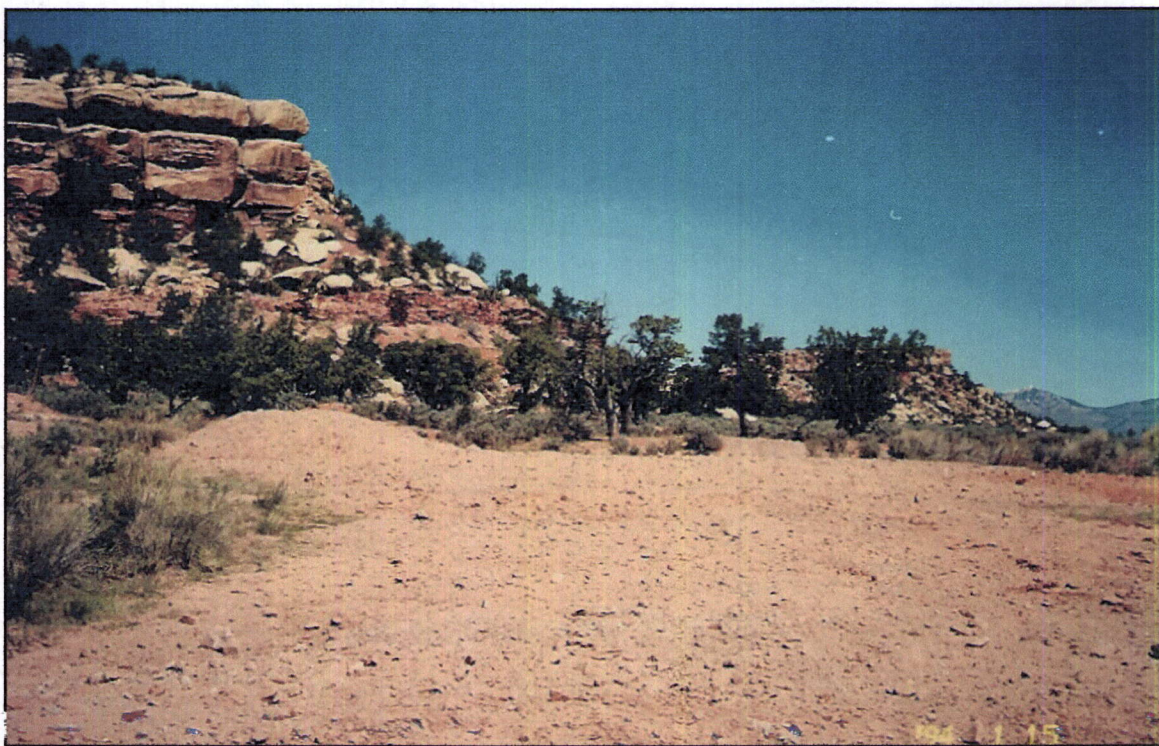
Photo 11: Reclaimed shaft area (former shaft located in left central portion of photograph).

overlapped the collar by 1 foot. A second piece of concrete was used to cover the remaining approximately 2 foot by 8 foot former shaft opening. The concrete covers were buried under approximately 2 feet of unconsolidated sediment obtained from the surface of the natural bench. The shaft area was graded level and ripped in preparation of seeding (Attachment A – Photograph 11).

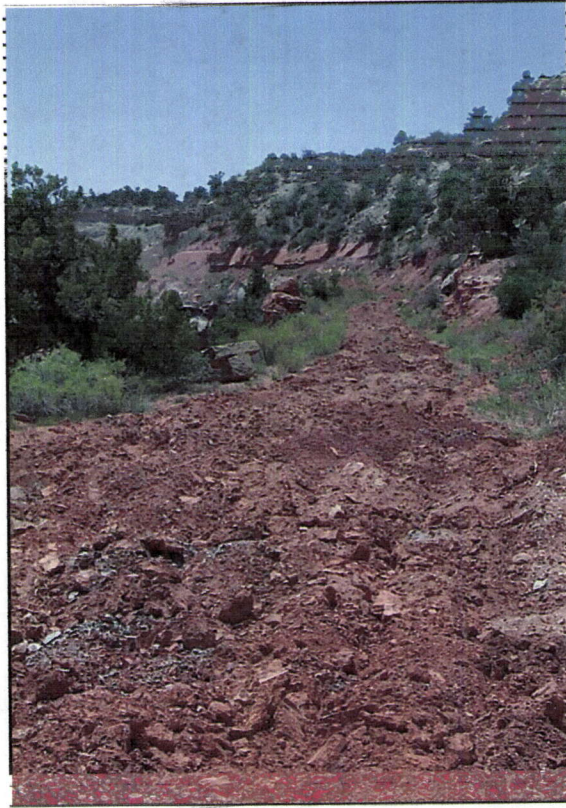
Photo 12: Reclaimed access road to portal h

All disturbed areas associated with access roads and former parking/storage areas were either ripped or pitted in preparation of seeding (Attachment A – Photograph 12). The primary mine access road was ripped from the mine area to the gated entrance at the county road. The mine gate was removed and a soil berm installed to protect the reclaimed area by discouraging vehicle access from the county road.

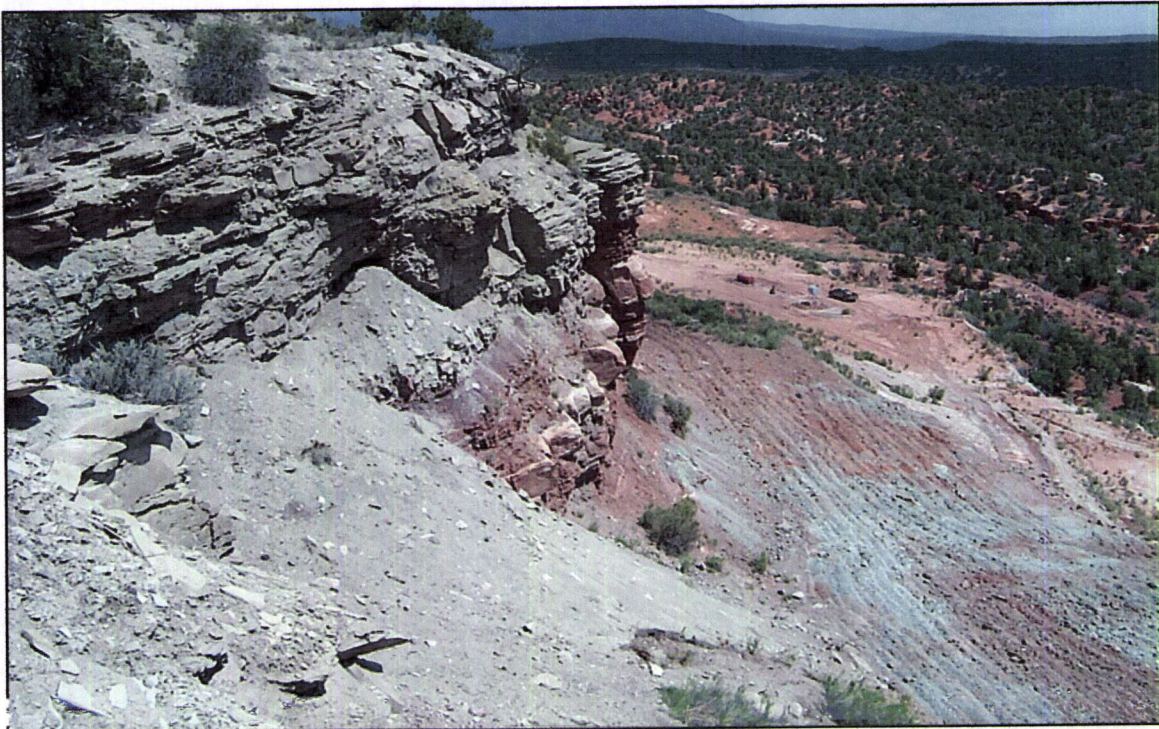
Photo 13: Reclaimed prospects/adits above former mine bench.

A number of small prospects and/or ancillary adits to the mine were located on the steep hillside above and south of the portal bench. The depth of the excavations ranged from only a few feet to possibly extending to the mine workings. The openings were sealed by backfilling the excavations with unconsolidated sediments. Backfill material was obtained from the hill slope below and above the excavations. The backfilled areas were graded to match the adjacent topography (Attachment A – Photograph 13).
